Alert Operators Transmission

Subject: Inspection of Fuselage Skin and FR5 LH/RH near Wing Leading Edge**Aircraft Type:** C-212**Applicability:** C-212 Fleet**Referenced Documents:**

Subject: Inspection of Fuselage Skin and FR5 LH/RH near Wing Leading Edge

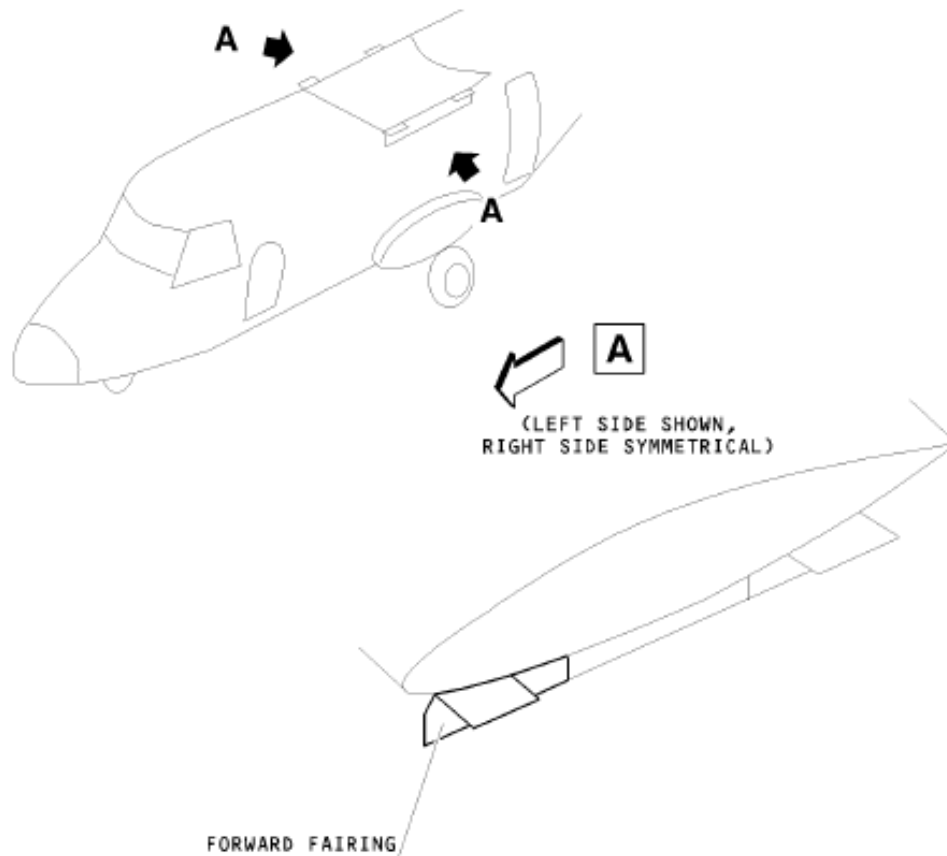
Figure 1. Inspection area location

The inspection area is defined in Figure 1 and Figure 2. The inspection must be performed on the fuselage skin edges and holes close to the edges around FR5 area and the upper to lower former joints, inner and outer caps, web and joint fittings at the joining area.

Perform a Detailed Visual Inspection (DVI) of the affected area following the rules of Ref. [5].

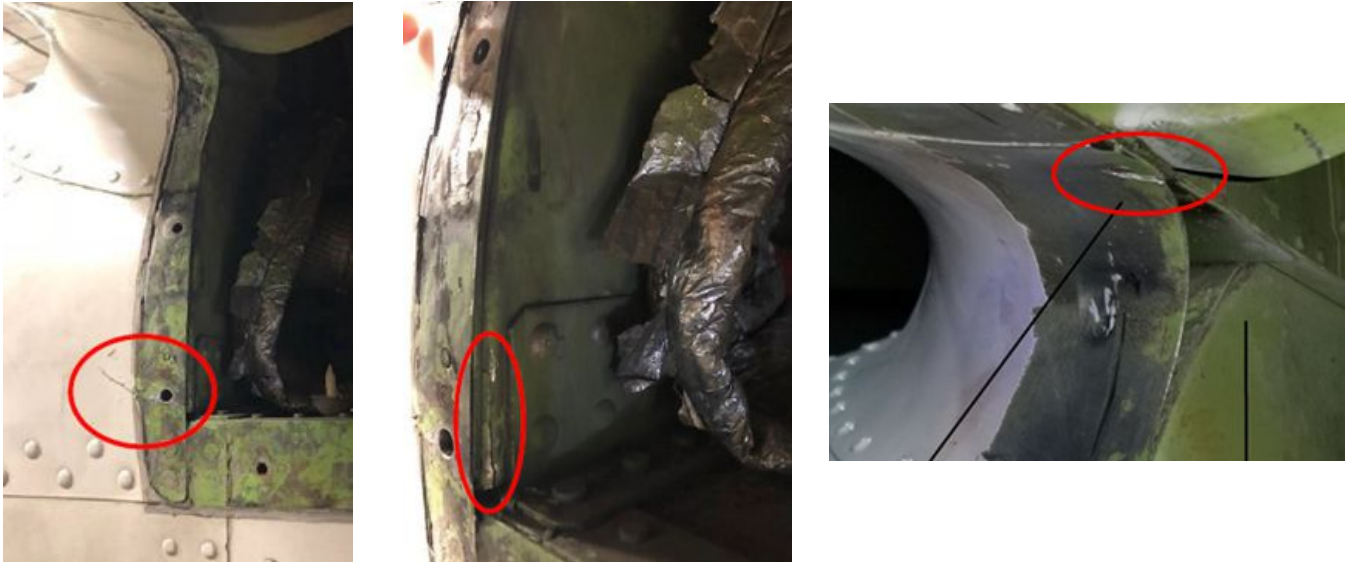
Cracks were located on the fuselage skin and on frame FR5 under the skin, near the leading edge of the wing, on both LH and RH sides.

Perform the inspection looking for cracks similar to the ones shown in Figure 3 and Figure 4.

Figure 3. Typical damages on LH wing

| In case of findings, report to Airbus Defence and Space the inspection results for further instructions.

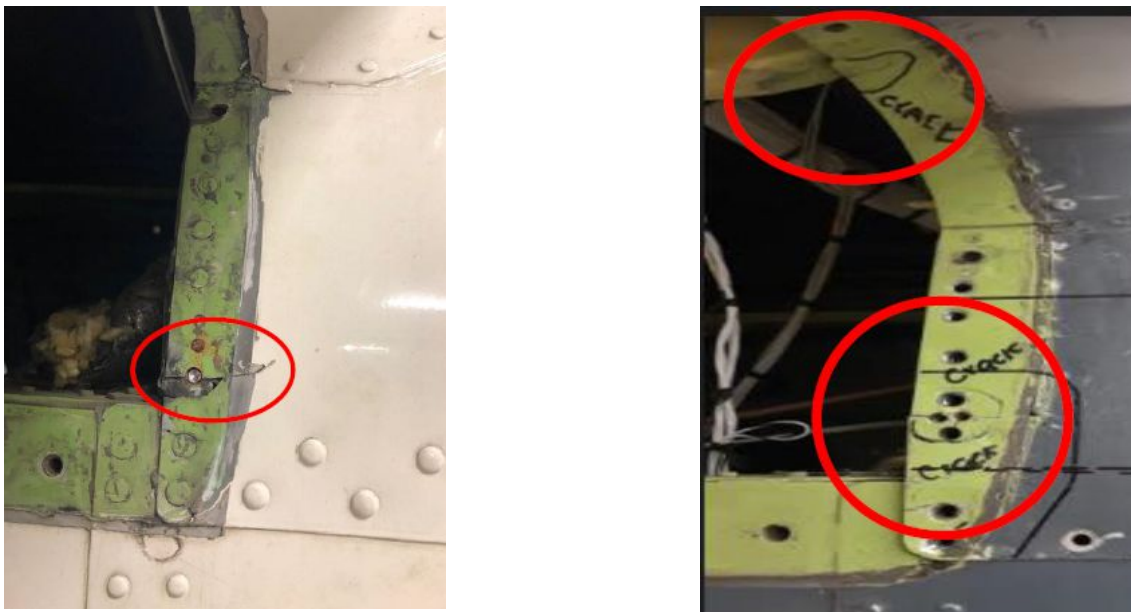
Figure 4. Typical damages on RH wing
